# Firmware Update

## GSR183

Relating to the critical fault in GPS183 & GNS183-UC clocks

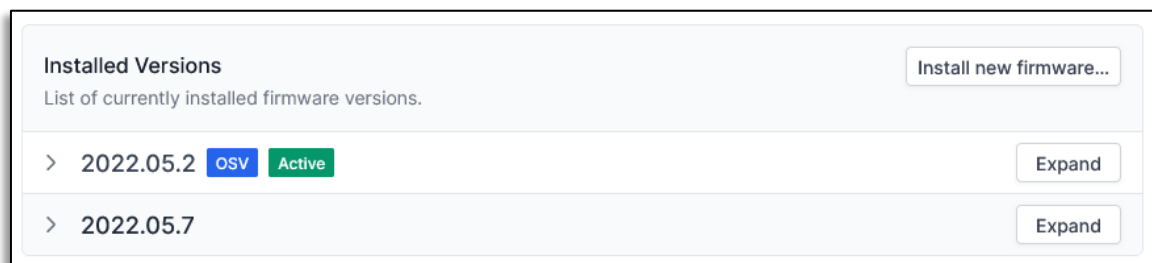
4. Access the “**Inventory**” page and click on “**Install New Firmware...**”.

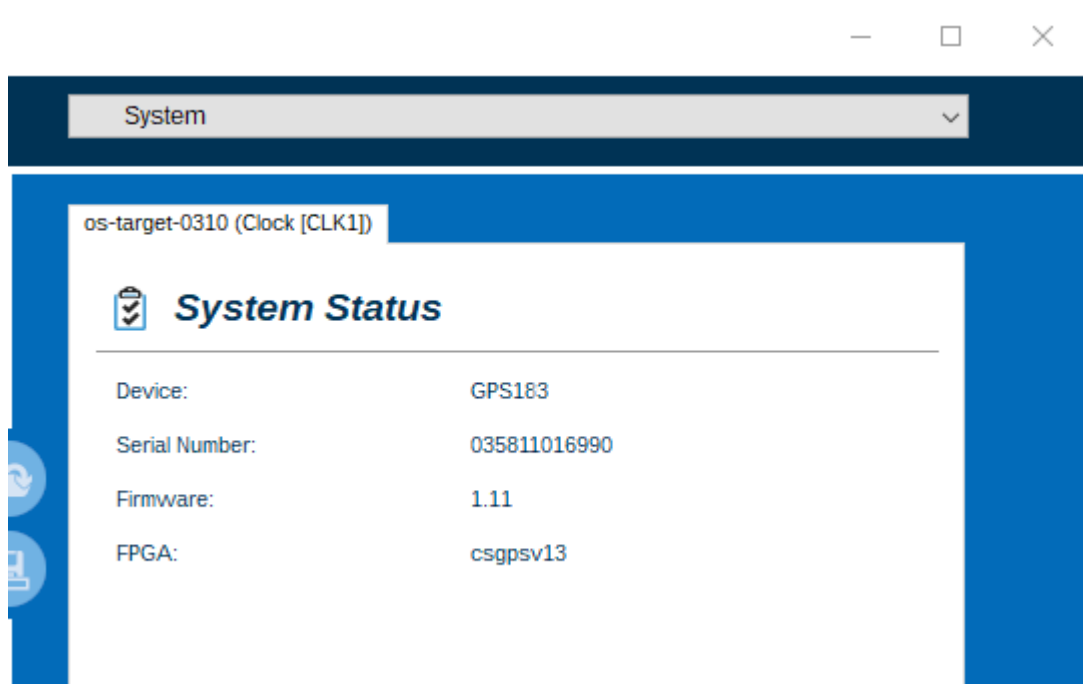
- opening Meinberg Device Manager, selecting “**System**” from the status panel on the right, opening the “**System**” page under “**Clock [CLK1]**”, and checking “**Firmware**”, which should be “**1.11**” or better.
